AFOSR-TR-80-1069

4. TITLE (and Subtitle) <b>ULTRASONIC AND ACOUSTIC EMISSION DETECTION OF FATIGUE DAMAGE</b>		5. TYPE OF REPORT & PERIOD COVERED <b>FINAL rept. MAR. 1, 1976 - MAY 31, 1980</b>

FINAL TECHNICAL REPORT

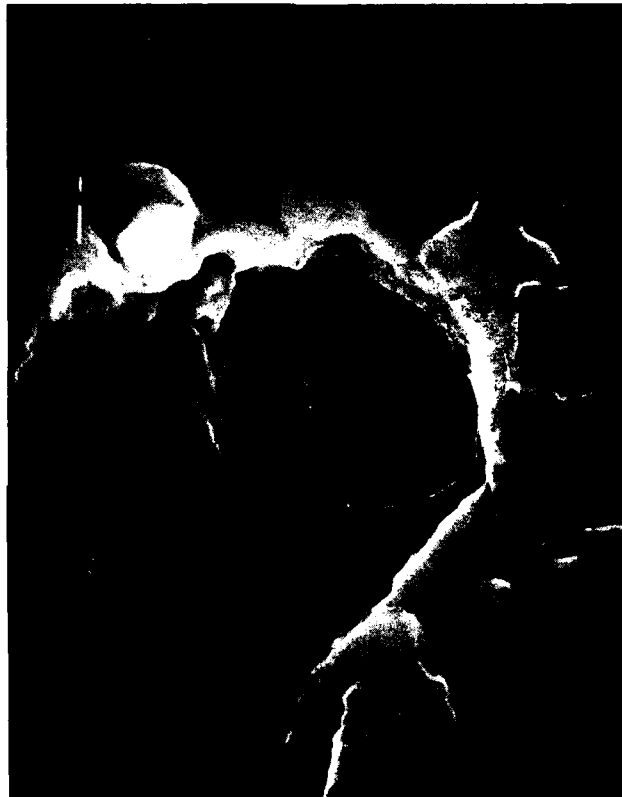
FIGURE 39. SCANNING ELECTRON MICROGRAPH (3800X)  
Void containing fractured inter-  
metallic particle

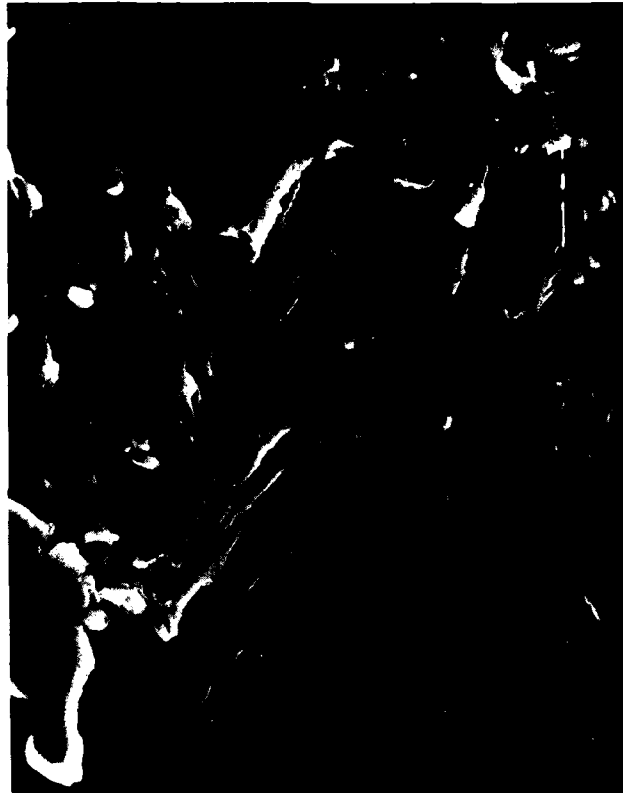
FIGURE 41. SCANNING ELECTRON MICROGRAPH(650X)  
As-received 7075-T651 aluminum  
Void coalescence at grain boundaries

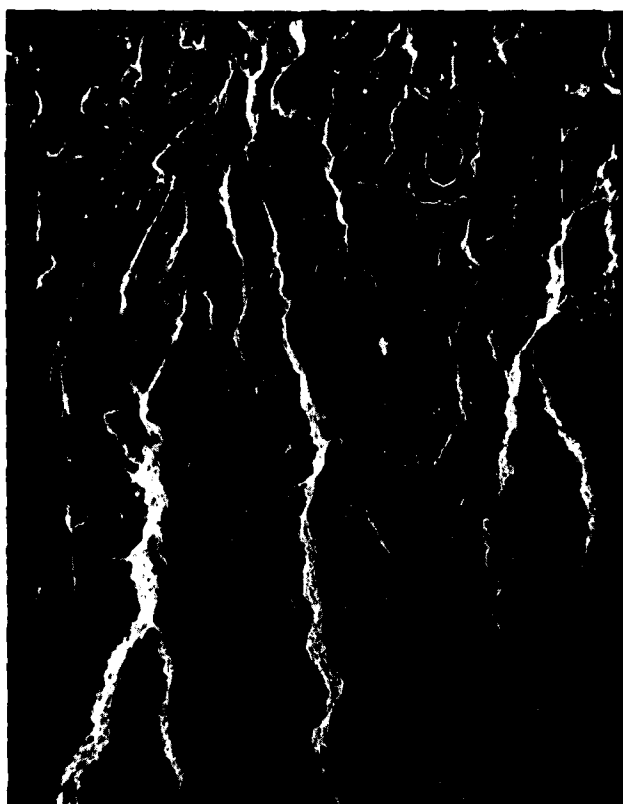
FIGURE 42. SCANNING ELECTRON MICROGRAPH(100X)  
Annealed 7075 aluminum  
Large fatigue striations
